# **PRELIMINARY REPORT ON MONITORING OF WATER TABLE AND SALINITY USING PIEZOMETERS IN THE MAKHATHINI IRRIGATION SCHEME**

**Department of Agriculture, Forestry and Fisheries  
Directorate: Water Use and Irrigation Development**

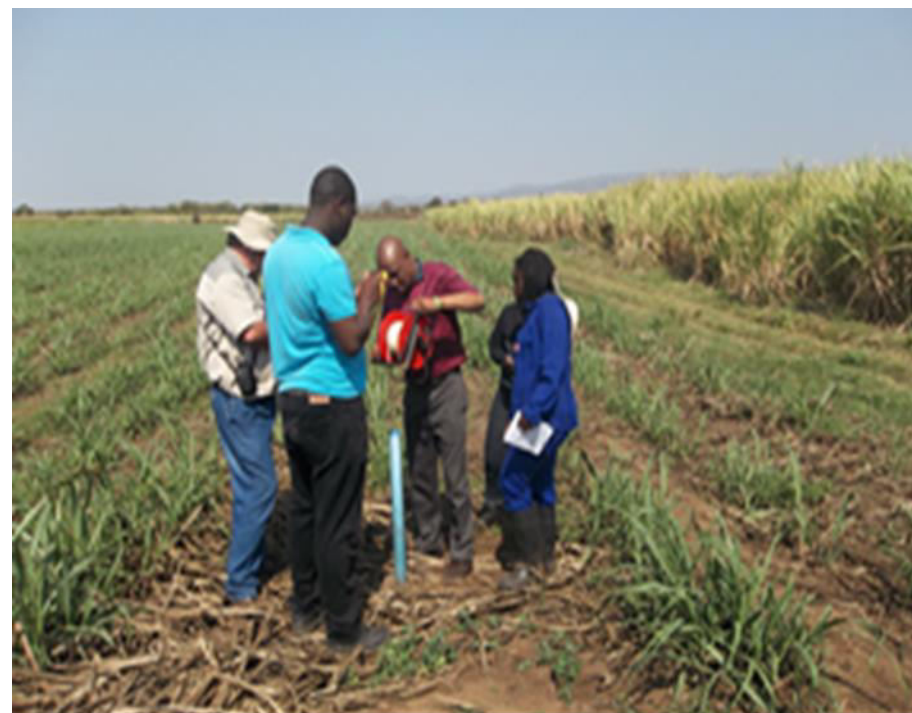
- A total of 281 piezometers were installed in five blocks (6A, 6B, 12, 15 and 19)
- The GPS co-ordinates and maps of the installed piezometers was provided by the KZN Provincial Department of Agriculture
- The Electrical Conductivity was measured
- The water level was measured using the piezometers
- The readings were taken 4 times in 14 months
- The main crops grown in the area are
  - sugarcane,
  - maize, and
  - variety of vegetables
